2011/2012 Annual Inspection Report

FRESHWATER BAYOU CANAL BANK STABILIZATION PROJECT (ME-13)

State Project Number ME-13
Priority Project List 5

May 16, 2012
Vermilion Parish

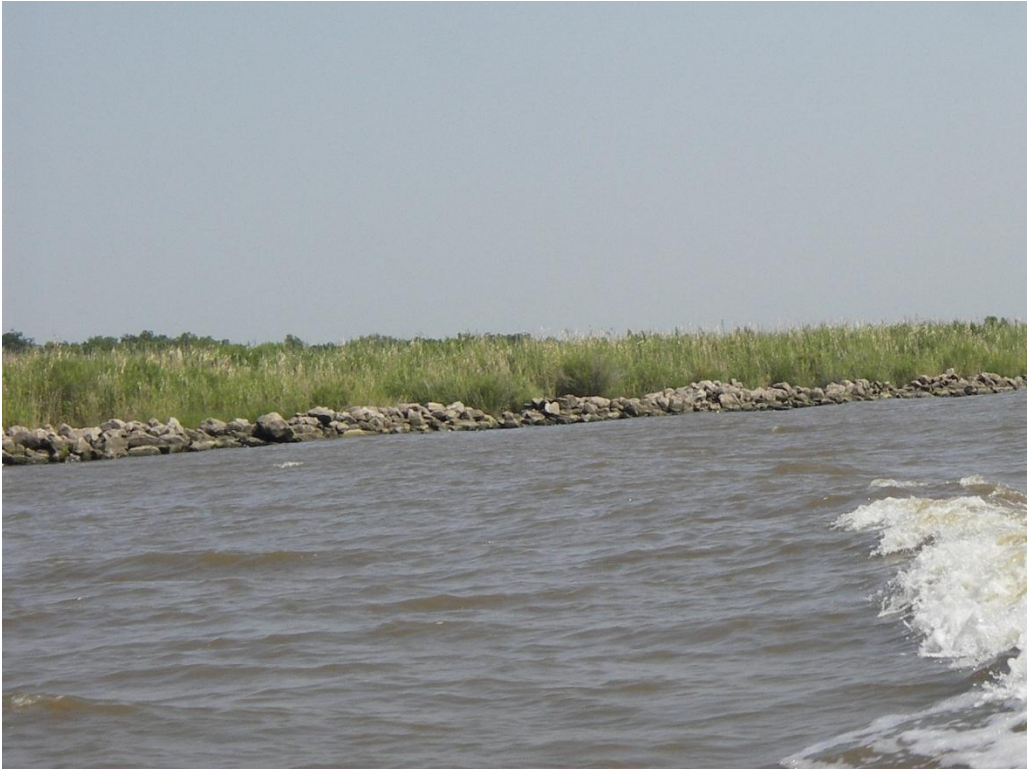
The inspection revealed the 9,130 linear feet of foreshore rock dike repaired in the 2005 maintenance project is in good condition. (Appendix B, Photos 1-2) The inspection noted numerous sections of foreshore rock dike that are below elevation 4.0 NAVD causing evident bank erosion. NRCS personnel previously performed a centerline profile survey of the foreshore rock dike along with cross-sections to determine the deficient reaches of the foreshore rock dike. Based on the surveys, NRCS and CPRA agreed to repair the deficient reaches of the foreshore rock dike to elevation 3.5' NAVD. Based on the survey information, NRCS computed the volume of rock required to cap the deficient reaches. CPRA will utilize the information from NRCS to prepare cost estimates for an O&M Funding Increase Request to the CWPPRA Task Force in the fall of 2012. (Appendix B, Photos 3-6)

Photo No. 1, Typical Rock Dike

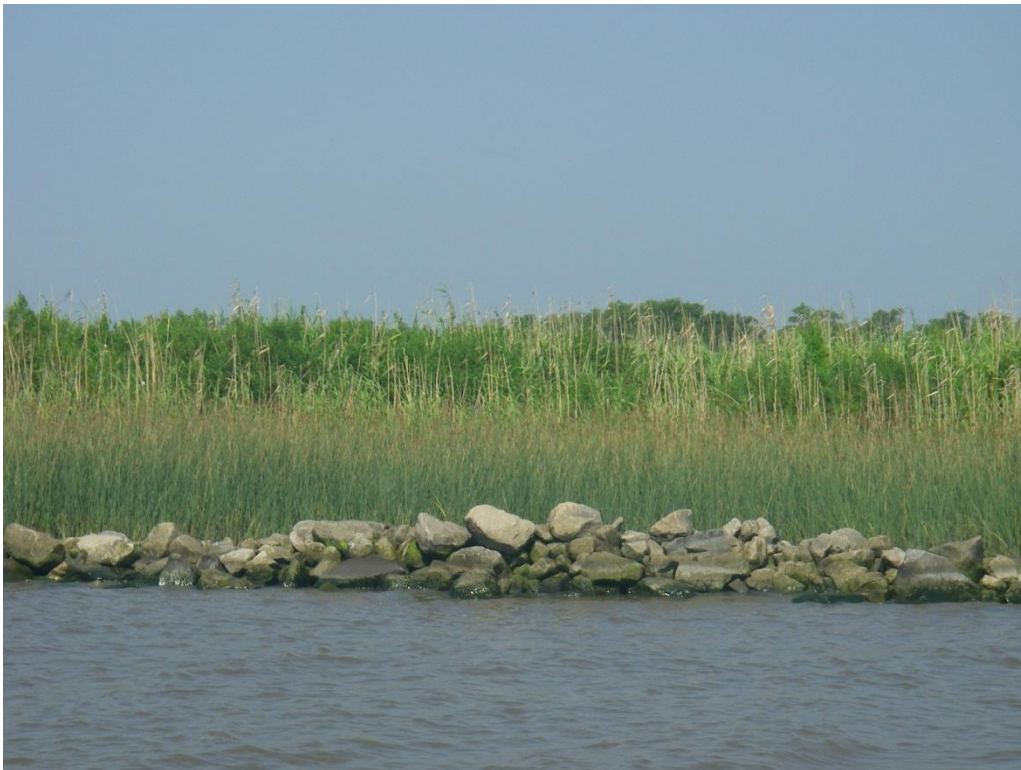
Photo No. 2, Vegetation Expansion up to Rock Dike

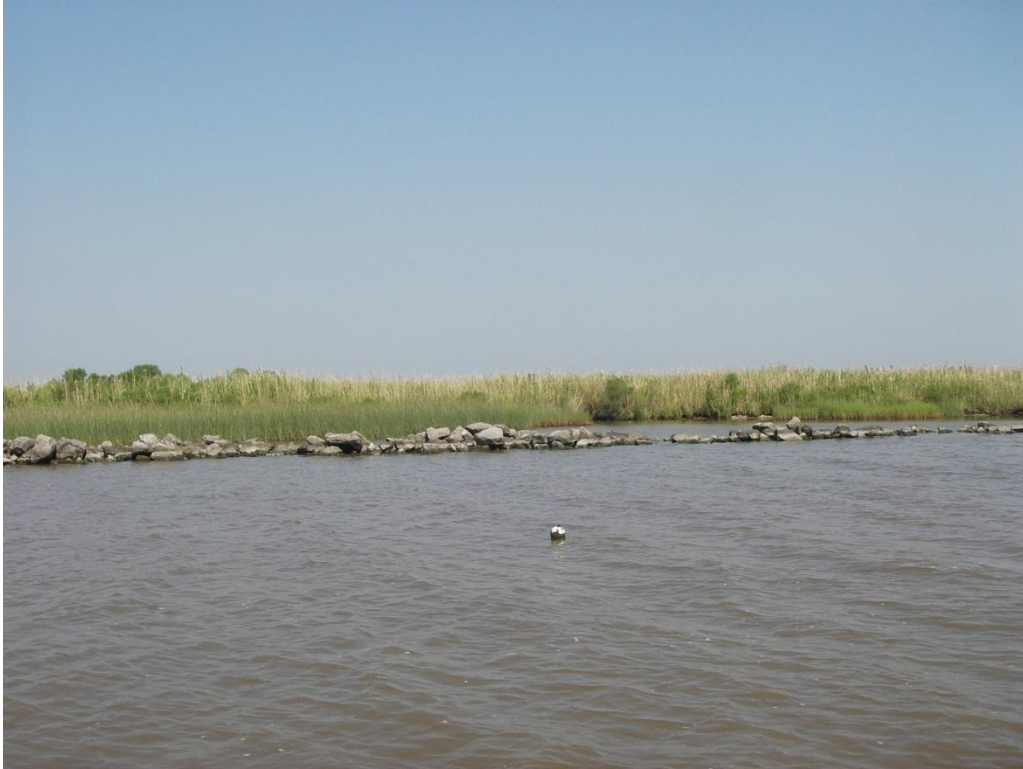
Photo No. 3, Low Area in Rock Dike but Continued Growth of Vegetation

Item	Condition	Physical Damage	Corrosion	Photo #	Observations and Remarks
Steel Bulkhead / Caps	N/A				
Steel Grating	N/A				
Stop Logs	N/A				
Hardware	N/A				
Timber Piles	N/A				
Timber Wales	N/A				
Galv. Pile Caps	N/A				
Cables	N/A				
Signage /Supports	N/A				
Rip Rap (fill) (foreshore dike)	Good			1,2	Maintenance work to restore dike to constructed elevation is still in good condition. Vegetation growth was noted.
				3,4,5	There are low areas along the rock dike which are producing bank erosion.
Earthen Embankment	N/A

Upon approval in FY12, the maintenance event to address the deficient reaches of foreshore rock dike is expected to begin in FY13-FY14. In an effort to reduce cost, the Engineering, Design and Construction of this maintenance event will be combined with the Freshwater Bayou Wetland protection Project (ME-04).

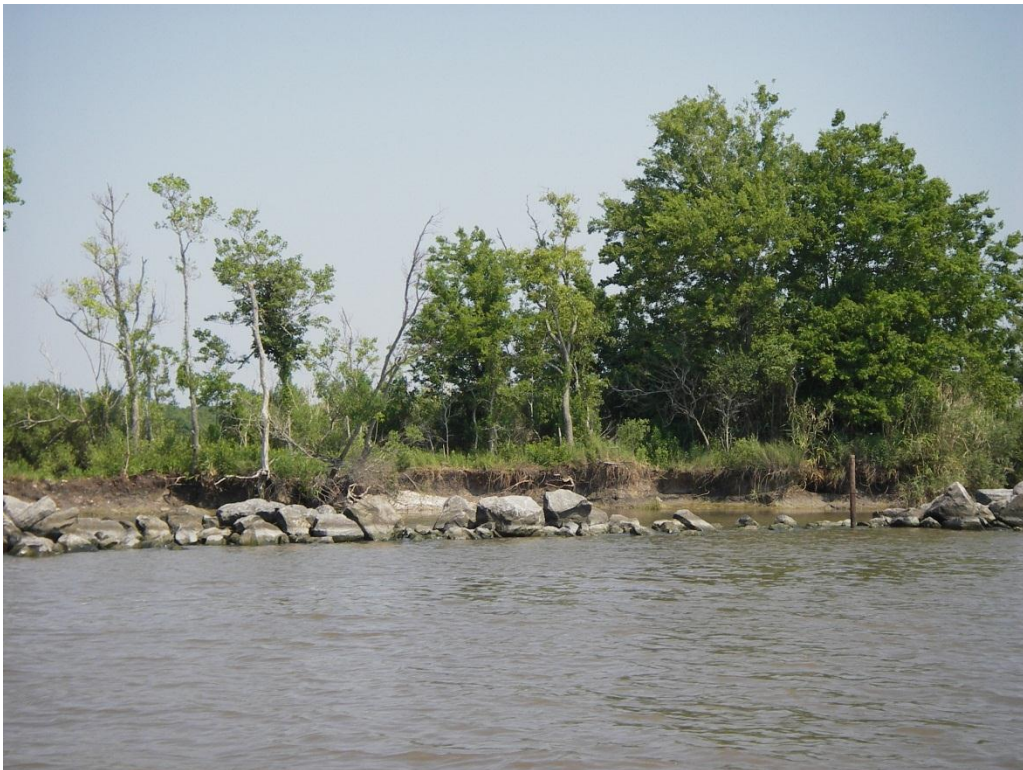
Photo No. 4, Erosion of Bank Behind Low Area in Rock Dike

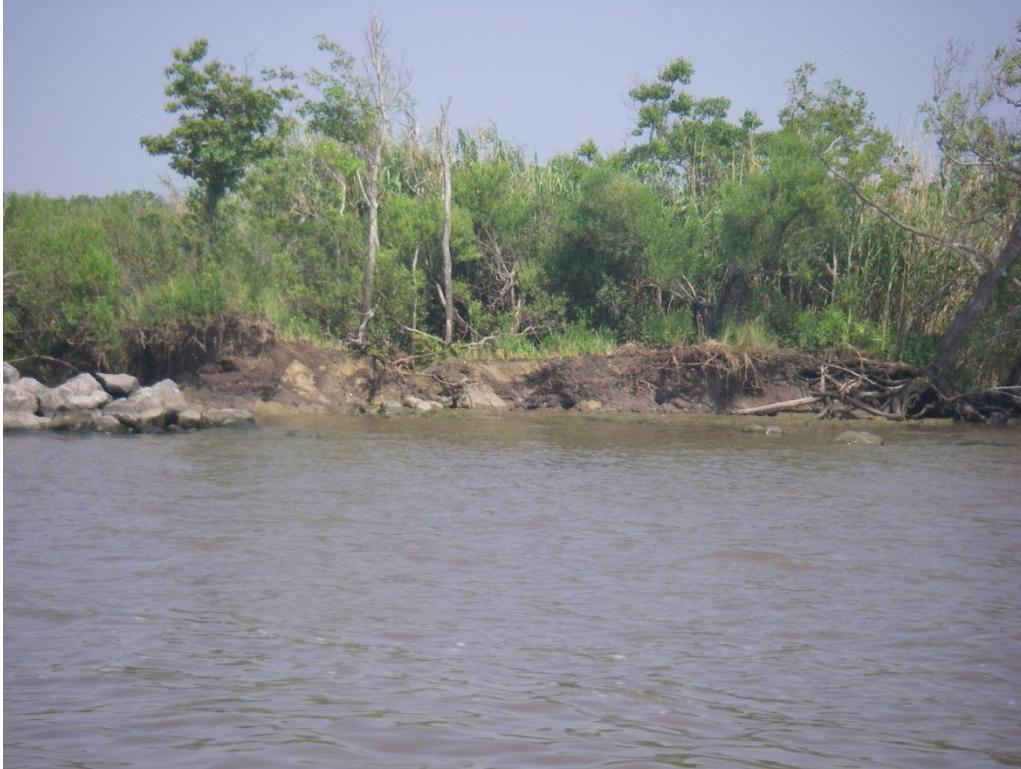
Photo No. 5, Erosion of Bank Behind Displaced Rock Dike

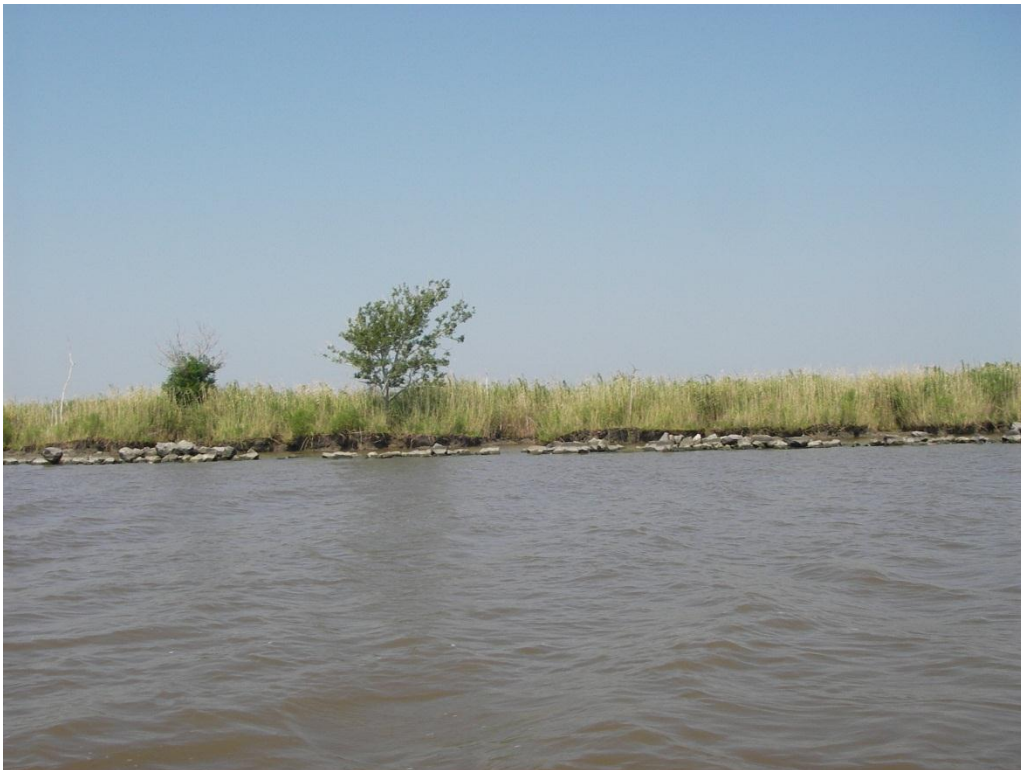
Photo No. 6, Erosion of Bank Behind Low Area in Rock Dike
